Physics Division ESH Bulletin 96-1

LIQUID NITROGEN DEWAR EXPLODES

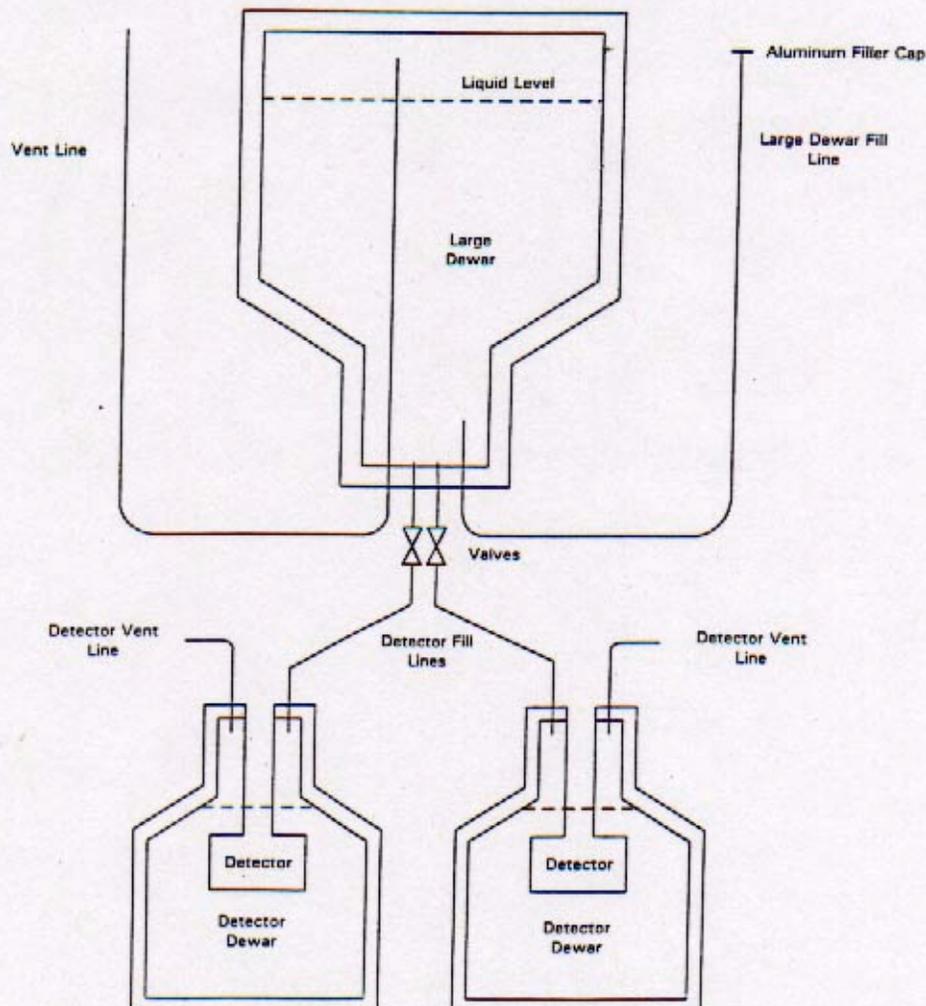
The explosion occurred in an experimental liquid nitrogen filling system designed by a technician in the Material Control and Accountability Group. The system (see Figure) consisted of an inverted 30-liter dewar, which fed nitrogen into two 1.5-liter dewars used to cool germanium detectors. The nitrogen flowed from the large dewar into the smaller ones through 0.25-inch outer-diameter, stainless-steel fill lines, each of which was equipped with a valve. The large dewar was equipped with a 0.5-inch fill valve and a 0.375-inch outer-diameter vent line.

Investigators determined that an obstructed vent line caused the inner vessel of the dewar to rupture, which allowed the liquid nitrogen to contact the outer vessel. Heat from the outer vessel vaporized the nitrogen, causing the explosion. Investigators believe a cap screw threaded into the end of the vent line after the dewar was topped off with nitrogen created the obstruction because photographs taken during the investigation show thread marks inside the vent line.

Investigators found that the flawed design of the gravity feed system contributed to the explosion. The valves used for the fill system were not cryogenic. The filler cap was made of aluminum and was not insulated, causing the nitrogen to boil off quickly. The vent line passed through the liquid nitrogen, allowing a freeze plug to form from condensation in the tube. The dewar flask was inverted to fill the germanium detector dewars, which placed abnormal structural loads on the fiberglass sleeve between the inner and outer vessels. In addition, the vent line did not provide adequate relief for the nitrogen, which expands by a factor of about 700 when it evaporates.

The group leader initiated several corrective actions as a result of this event. He instructed all personnel in writing that any new activity or change in existing operation, other than routine office activity, must be reviewed by the section leader. He arranged for the technicians involved in the incident to receive cryogenic and pressure safety training and for a commercial fill system to be purchased. He had a safe operating procedure governing the use of liquid nitrogen developed and established a system of annual safety inspections and daily facility walkdowns.
